**Flood Control Project Maintenance
Levee Inspections**

Maintenance Issue Types Only, Levee Inspection Report By Mile - Spring 2015

San Joaquin County Flood Control and Water Conservation District

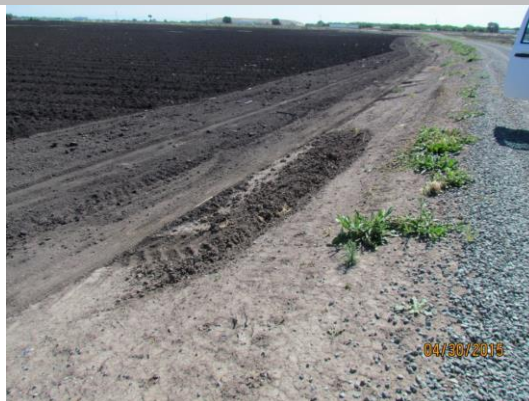
Photo 1 of 1 : SP_2015_NA0017_149_125_20150506_00169.jpg

A slope instability was found on the landside of the levee looking upstream.

LM Start	0.29	Rating **	M	Issue No.	125
LM End	0.29	Issue Type +	Ma	Location *	LS
Category	Earthen Levee			GPS Latitude/Longitude	
				Start	End
Item	Slope Stability			37.875189 °	37.875189 °
				-121.225048 °	-121.225048 °
DWR ID	DWR_NA0017_02_s _ 2015_125				
Action/Comments					
Repair the levee slope damaged by vehicle traffic and prevent access where possible.

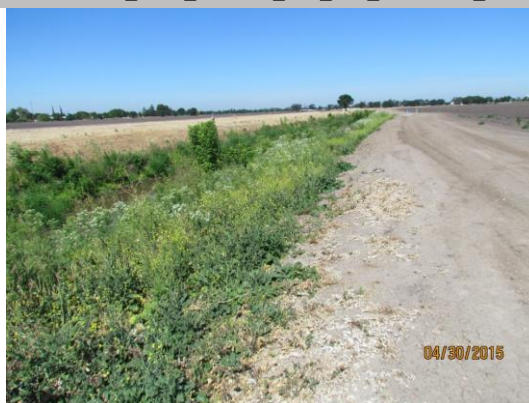
Photo 1 of 1 : SP_2015_NA0017_149_126_20150506_00170.jpg

View of vegetation along waterside looking downstream.

LM Start	1.91	Rating **	M	Issue No.	126
LM End	1.97	Issue Type +	Ma	Location *	WS
Category	Earthen Levee			GPS Latitude/Longitude	
				Start	End
Item	Vegetation			37.881827 °	37.882404 °
				-121.249428 °	-121.250357 °
DWR ID	DWR_NA0017_02_s _ 2015_126				
Action/Comments					
Control annual grass and weeds on the levee slopes and easements.

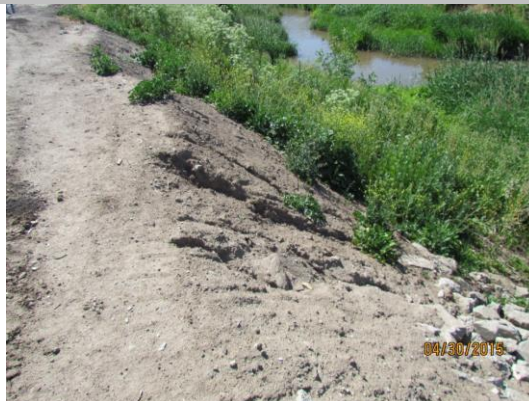
Photo 1 of 1 : SP_2015_NA0017_149_127_20150506_00171.jpg

Erosion was found on the waterside slope of the levee looking upstream.

LM Start	1.97	Rating **	M	Issue No.	127
LM End	1.97	Issue Type +	Ma	Location *	WS
Category	Earthen Levee			GPS Latitude/Longitude	
				Start	End
Item	Erosion / Bank Caving			37.882404 °	37.882404 °
				-121.250359 °	-121.250359 °
DWR ID	DWR_NA0017_02_s _ 2015_127				
Action/Comments					
Note and monitor erosion site.

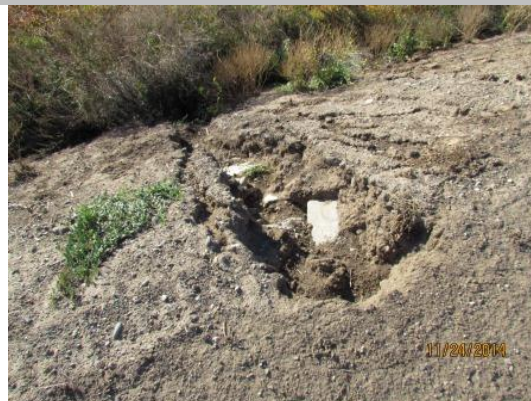
Photo 2 of 2 : SP_2015_NA0017_149_4_20150313_00003.jpg

Erosion on the waterside of the levee looking downstream.

LM Start	2.22	Rating **	M	Issue No.	4 (cont)	
LM End	2.22	Issue Type +	Ma	Location *	WS	
Category	Earthen Levee			GPS Latitude/Longitude		
				Start		End
Item	Erosion / Bank Caving			37.884741 °	37.884741 °	
				-121.253808 °	-121.253808 °	
DWR ID	DWR_NA0017_02_s_2014_4					
Action/Comments						
Schedule repair of erosion site prior to the next inspection.

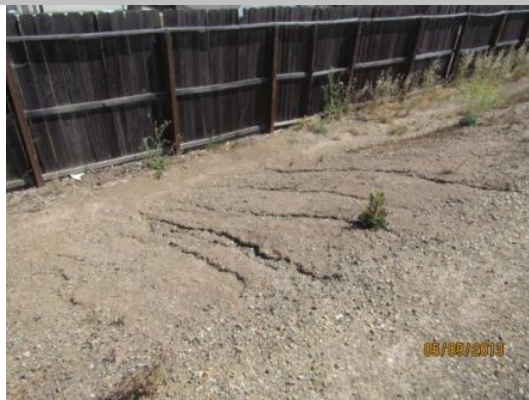
Photo 1 of 1 : SP_2015_NA0017_151_2_20150313_00002.jpg

Erosion was found on the landside of the levee looking upstream.

LM Start	0.69	Rating **	M	Issue No.	2
LM End	0.69	Issue Type +	Ma	Location *	LS
Category	Earthen Levee			GPS Latitude/Longitude	
				Start	End
Item	Erosion / Bank Caving			38.043468 °	38.043468 °
				-121.361022 °	-121.361022 °
DWR ID	DWR_NA0017_07_s_2013_2				
Action/Comments					
Schedule repair of erosion site prior to the next inspection.

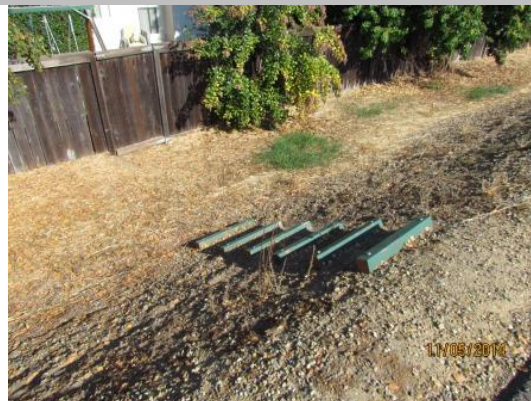
Photo 1 of 1 : SP_2015_NA0017_151_76_20150313_00033.jpg

A stairway was found on the landside of the levee looking upstream.

LM Start	1.54	Rating **	M	Issue No.	76
LM End	1.54	Issue Type +	Ma	Location *	LS
Category	Earthen Levee			GPS Latitude/Longitude	
				Start	End
Item	Encroachments			38.043304 °	38.043304 °
				-121.345485 °	-121.345485 °
DWR ID	DWR_NA0017_07_f_2014_76				
Action/Comments					
Stairway

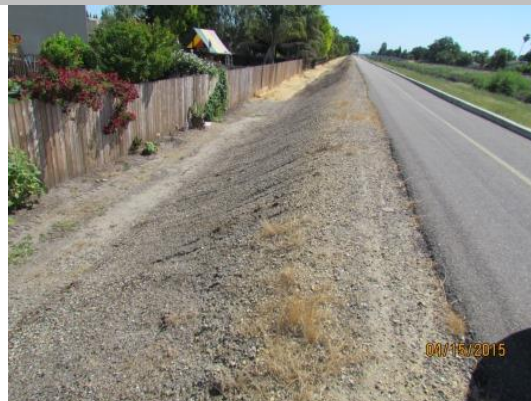
Photo 1 of 1 : SP_2015_NA0017_151_35_20150421_00063.jpg

Slope instability caused by runoff on the landside of the levee looking upstream.

LM Start	2.01	Rating **	M	Issue No.	35
LM End	2.01	Issue Type +	Ma	Location *	LS
Category	Earthen Levee			GPS Latitude/Longitude	
				Start	End
Item	Slope Stability			38.043243 °	38.043243 °
				-121.336780 °	-121.336780 °
DWR ID	DWR_NA0017_07_s_2015_35				
Action/Comments					
Repair slope instability. Inspector Comments: Runoff

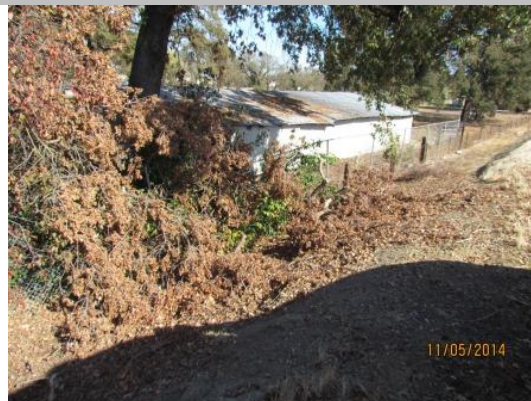
Photo 1 of 1 : SP_2015_NA0017_151_81_20150313_00035.jpg

Prunings were found on the landside toe of the levee looking upstream.

LM Start	2.32	Rating **	M	Issue No.	81
LM End	2.32	Issue Type +	Ma	Location *	LS
Category	Earthen Levee			GPS Latitude/Longitude	
				Start	End
Item	Encroachments			38.043213 °	38.043213 °
				-121.331189 °	-121.331189 °
DWR ID	DWR_NA0017_07_f_2014_81				
Action/Comments					
Prunings

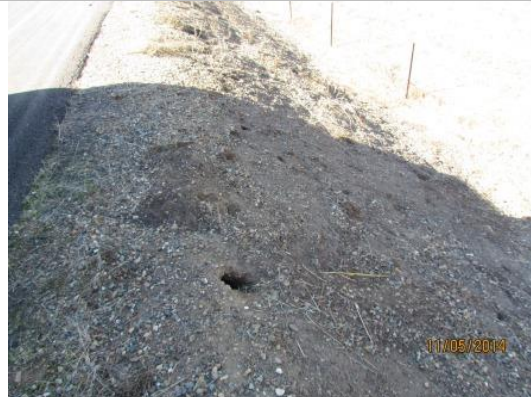
Photo 1 of 1 : SP_2015_NA0017_151_83_20150313_00036.jpg

Rodent holes were found on the landside of the levee looking downstream.

LM Start	2.71	Rating **	M	Issue No.	83
LM End	2.71	Issue Type +	Ma	Location *	LS
Category	Earthen Levee			GPS Latitude/Longitude	
				Start	End
Item	Animal Control			38.043189 °	38.043189 °
				-121.323881 °	-121.323881 °
DWR ID	DWR_NA0017_07_f_2014_83				
Action/Comments					
No rodents visible, but rodent burrows visible; need to backfill and compact or grout burrows.

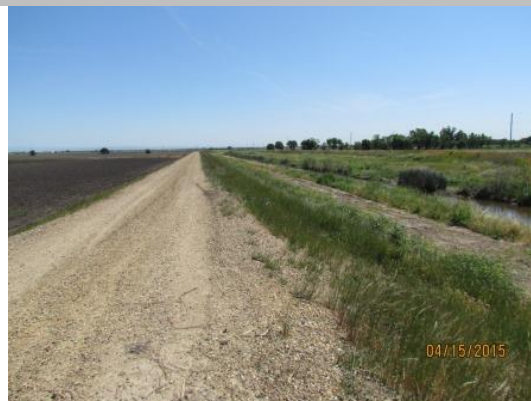
Photo 1 of 1 : SP_2015_NA0017_151_37_20150421_00064.jpg

Vegetation on the waterside of the levee looking upstream.

LM Start	3.09	Rating **	M	Issue No.	37
LM End	5.48	Issue Type +	Ma	Location *	WS
Category	Earthen Levee			GPS Latitude/Longitude	
				Start	End
Item	Vegetation			38.043203 °	38.052769 °
				-121.316953 °	-121.277933 °
DWR ID	DWR_NA0017_07_s_2015_37				
Action/Comments					
Control annual grass and weeds on the levee slopes and easements.

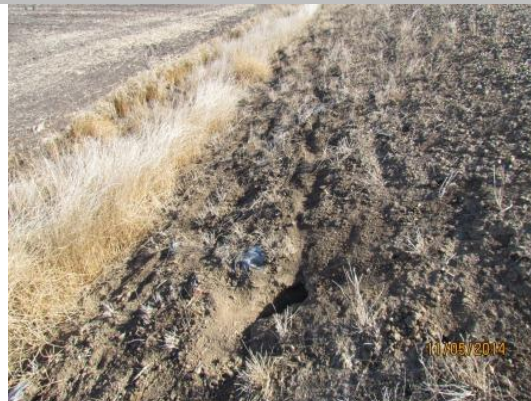
Photo 1 of 1 : SP_2015_NA0017_151_86_20150313_00037.jpg

An animal hole was found on the landside of the levee looking upstream.

LM Start	3.34	Rating **	M	Issue No.	86
LM End	3.34	Issue Type +	Ma	Location *	LS
Category	Earthen Levee			GPS Latitude/Longitude	
				Start	End
Item	Animal Control			38.043126 °	38.043126 °
				-121.312462 °	-121.312462 °
DWR ID	DWR_NA0017_07_f_2014_86				
Action/Comments					
No rodents visible, but rodent burrows visible; need to backfill and compact or grout burrows.

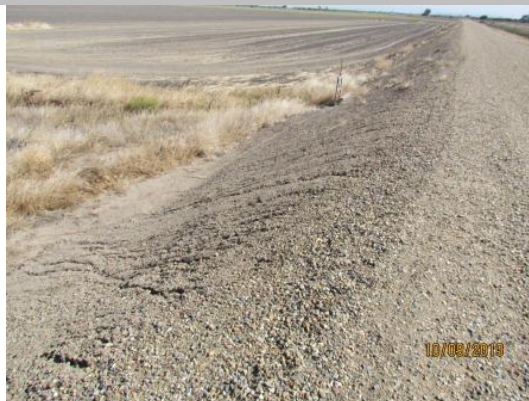
Photo 1 of 1 : SP_2015_NA0017_151_24_20150313_00007.jpg

View of erosion occurred due to runoff on the landside slope of the levee looking upstream.

LM Start	3.48	Rating **	M	Issue No.	24
LM End	3.48	Issue Type +	Ma	Location *	LS
Category	Earthen Levee			GPS Latitude/Longitude	
				Start	End
Item	Erosion / Bank Caving			38.043025 °	38.043025 °
				-121.309918 °	-121.309918 °
DWR ID	DWR_NA0017_07_f_2013_24				
Action/Comments					
Schedule repair of erosion site prior to the next inspection.					
Inspector Comments: Runoff was discovered.

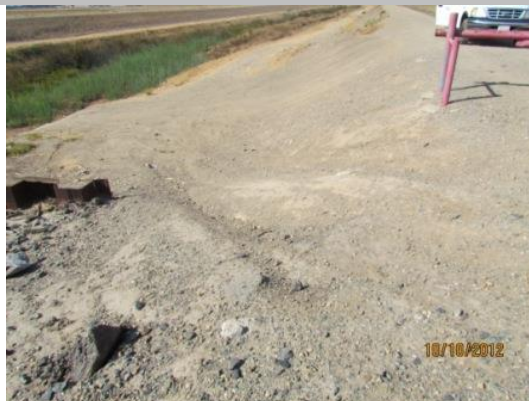
Photo 1 of 1 : SP_2015_NA0017_151_73_20150313_00032.jpg

Slope instability was found on the landside of the levee looking upstream.

LM Start	5.50	Rating **	M	Issue No.	73
LM End	5.50	Issue Type +	Ma	Location *	WS
Category	Earthen Levee			GPS Latitude/Longitude	
				Start	End
Item	Slope Stability			38.052753 °	38.052753 °
				-121.277680 °	-121.277680 °
DWR ID	DWR_NA0017_07_f_2012_73				
Action/Comments					
Repair the levee slope damaged by vehicle traffic and prevent access where possible.

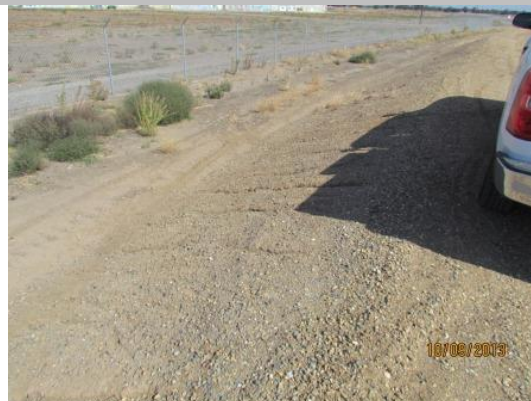
Photo 1 of 1 : SP_2015_NA0017_151_43_20150313_00016.jpg

Runoff was found on the landside slope of the levee looking upstream.

LM Start	5.53	Rating **	M	Issue No.	43
LM End	5.53	Issue Type +	Ma	Location *	LS
Category	Earthen Levee			GPS Latitude/Longitude	
				Start	End
Item	Erosion / Bank Caving			38.052794 °	38.052794 °
				-121.277035 °	-121.277035 °
DWR ID	DWR_NA0017_07_f_2013_43				
Action/Comments					
Schedule repair of erosion site prior to the next inspection. Inspector Comments: Runoff on the landside.

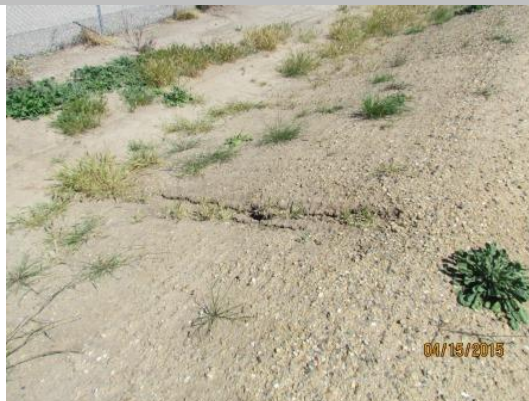
Photo 1 of 1 : SP_2015_NA0017_151_51_20150421_00065.jpg

Slope instability caused by runoff on the landside of the levee looking upstream.

LM Start	5.63	Rating **	M	Issue No.	51
LM End	5.63	Issue Type +	Ma	Location *	LS
Category	Earthen Levee			GPS Latitude/Longitude	
				Start	End
Item	Slope Stability			38.052849 °	38.052849 °
				-121.275175 °	-121.275175 °
DWR ID	DWR_NA0017_07_s_2015_51				
Action/Comments					
Repair slope instability. Inspector Comments: Runoff

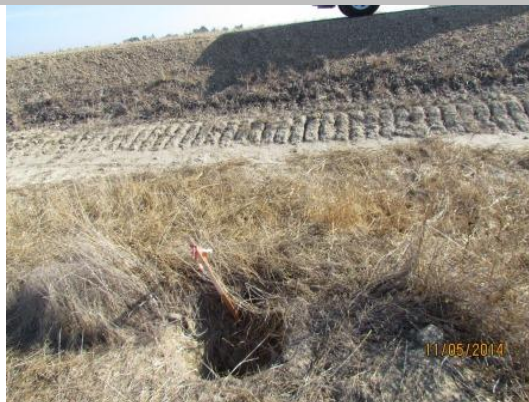
Photo 1 of 1 : SP_2015_NA0017_151_93_20150313_00041.jpg

LM Start	5.97	Rating **	M	Issue No.	93
LM End	5.97	Issue Type +	Ma	Location *	LS
Category	Earthen Levee			GPS Latitude/Longitude	
				Start	End
Item	Encroachments			38.053816 °	38.053816 °
				-121.269136 °	-121.269136 °
DWR ID	DWR_NA0017_07_f_2014_93				
Action/Comments					
Debris					
Inspector Comments: The hole was drilled for testing purpose on the landside toe of the levee.

A hole was found on the landside toe of the levee.

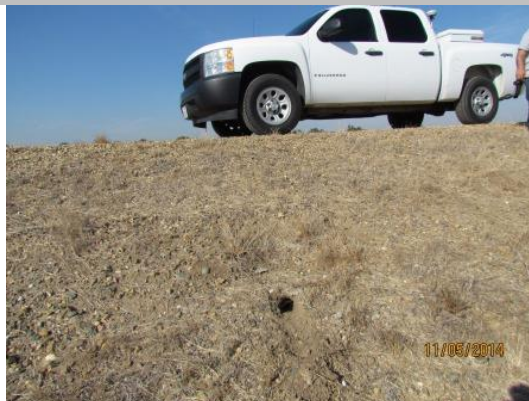
Photo 1 of 1 : SP_2015_NA0017_151_87_20150313_00038.jpg

An animal hole was on the waterside of the levee looking upstream.

LM Start	6.03	Rating **	M	Issue No.	87
LM End	6.03	Issue Type +	Ma	Location *	WS
Category	Earthen Levee			GPS Latitude/Longitude	
				Start	End
Item	Animal Control			38.054191 °	38.054191 °
				-121.268250 °	-121.268250 °
DWR ID	DWR_NA0017_07_f_2014_87				
Action/Comments					
No rodents visible, but rodent burrows visible; need to backfill and compact or grout burrows.

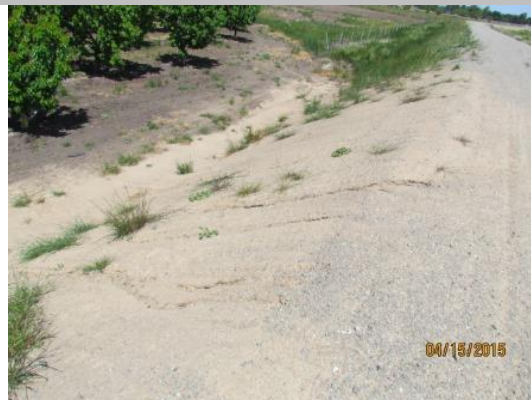
Photo 1 of 1 : SP_2015_NA0017_151_63_20150421_00066.jpg

Slope instability was found on the landside of the levee looking upstream.

LM Start	7.09	Rating **	M	Issue No.	63
LM End	7.09	Issue Type +	Ma	Location *	LS
Category	Earthen Levee			GPS Latitude/Longitude	
				Start	End
Item	Slope Stability			38.063929 °	38.063929 °
				-121.254950 °	-121.254950 °
DWR ID	DWR_NA0017_07_s_2015_63				
Action/Comments					
Repair slope instability. Inspector Comments: Runoff

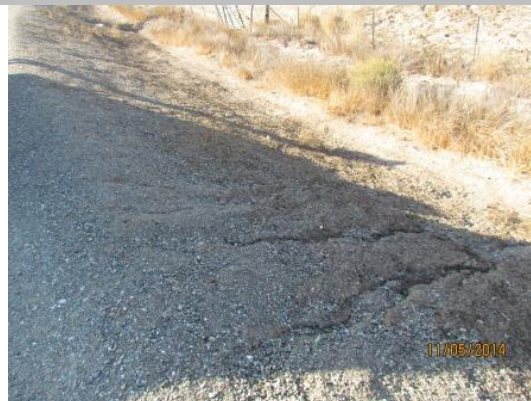
Photo 1 of 1 : SP_2015_NA0017_151_102_20150313_00048.jpg

View of erosion caused by runoff found on the landside of the levee looking downstream.

LM Start	7.33	Rating **	M	Issue No.	102
LM End	7.33	Issue Type +	Ma	Location *	LS
Category	Earthen Levee			GPS Latitude/Longitude	
				Start	End
Item	Erosion / Bank Caving			38.064983 °	38.064983 °
				-121.251043 °	-121.251043 °
DWR ID	DWR_NA0017_07_f_2014_102				
Action/Comments					
Schedule repair of erosion site prior to the next inspection.					
Inspector Comments: Runoff

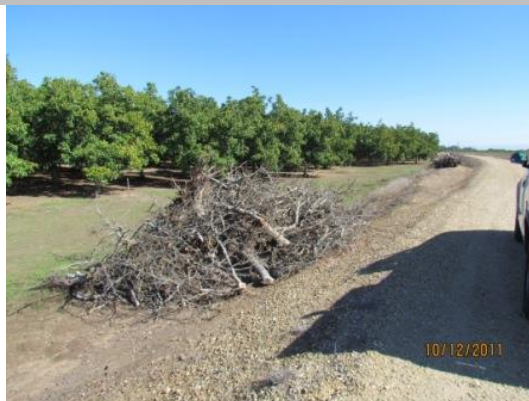
Photo 1 of 1 : SP_2015_NA0017_151_29_20150313_00009.jpg

LM Start	8.44	Rating **	M	Issue No.	29
LM End	8.44	Issue Type +	Ma	Location *	LS
Category	Earthen Levee			GPS Latitude/Longitude	
				Start	End
Item	Encroachments			38.068319 °	38.068319 °
				-121.231559 °	-121.231559 °
DWR ID	DWR_NA0017_07_s_2012_29				
Action/Comments					
Prunings					
Inspector Comments: Burn pile has been burned but new material has been placed.

View of prunings found on the landside of the levee looking upstream.

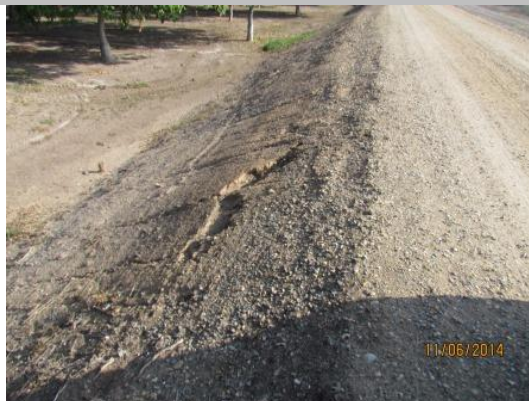
Photo 1 of 1 : SP_2015_NA0017_151_104_20150313_00050.jpg

LM Start	9.54	Rating **	M	Issue No.	104
LM End	9.54	Issue Type +	Ma	Location *	LS
Category	Earthen Levee			GPS Latitude/Longitude	
				Start	End
Item	Erosion / Bank Caving			38.073812 °	38.073812 °
				-121.213770 °	-121.213770 °
DWR ID	DWR_NA0017_07_f_2014_104				
Action/Comments					
Schedule repair of erosion site prior to the next inspection.					
Inspector Comments: Runoff

View of erosion caused by surface runoff found on the landside slope of the levee looking upstream.

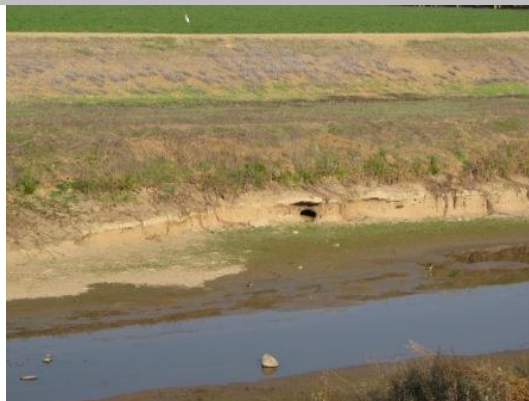
Photo 1 of 1 : SP_2015_NA0017_151_80_20150313_00034.jpg

LM Start	9.65	Rating **	U	Issue No.	80
LM End	9.65	Issue Type +	Ma	Location *	WS
Category	Earthen Levee			GPS Latitude/Longitude	
				Start	End
Item	Animal Control			38.070458 °	38.070458 °
				-121.218596 °	-121.218596 °
DWR ID	DWR_NA0017_07_s_2012_80				
Action/Comments					
No rodents visible, but rodent burrows visible; need to backfill and compact or grout burrows.					
Inspector Comments: Beaver den in the waterward berm visible from the opposite bank.

View of a large hole and several smaller holes from across the channel.

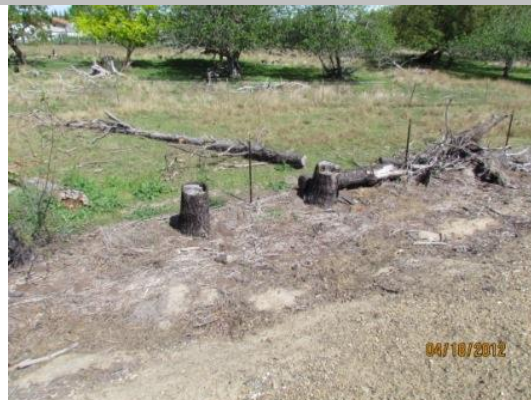
Photo 1 of 1 : SP_2015_NA0017_151_46_20150313_00018.jpg

LM Start	9.76	Rating **	N	Issue No.	46
LM End	9.76	Issue Type +	Ma	Location *	LS
Category	Earthen Levee			GPS Latitude/Longitude	
				Start	End
Item	Trim / Thin Trees			38.074613 °	38.074613 °
				-121.209882 °	-121.209882 °
DWR ID	DWR_NA0017_07_s_2012_46				
Action/Comments					
Tree stumps.

View of tree stumps found on the landside of the levee looking upstream.

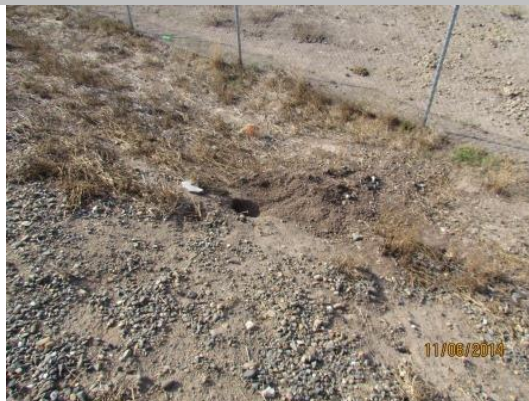
Photo 1 of 1 : SP_2015_NA0017_151_107_20150313_00053.jpg

LM Start	12.37	Rating **	M	Issue No.	107
LM End	12.37	Issue Type +	Ma	Location *	LS
Category	Earthen Levee			GPS Latitude/Longitude	
				Start	End
Item	Animal Control			38.096788 °	38.096788 °
				-121.176614 °	-121.176614 °
DWR ID	DWR_NA0017_07_f_2014_107				
Action/Comments					
No rodents visible, but rodent burrows visible; need to backfill and compact or grout burrows.

An animal hole was found on the landside of the levee looking downstream.

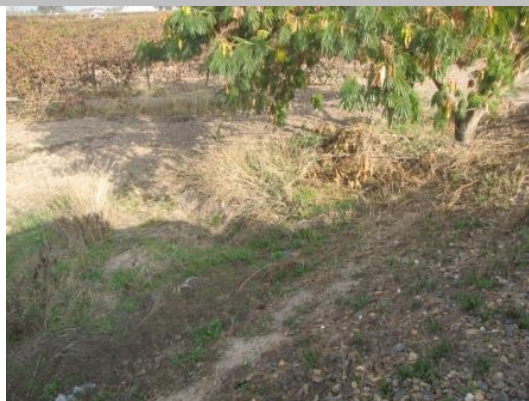
Photo 1 of 1 : SP_2015_NA0017_151_72_20150313_00031.jpg

LM Start	13.03	Rating **	M	Issue No.	72
LM End	13.03	Issue Type +	Ma	Location *	LS
Category	Earthen Levee			GPS Latitude/Longitude	
				Start	End
Item	Slope Stability			38.105846 °	38.105846 °
				-121.176552 °	-121.176552 °
DWR ID	DWR_NA0017_07_s_2012_72				
Action/Comments					
Repair slope instability. Inspector Comments: Shallow pit at the landward toe with nearby prunings.

View of a pit along the landward levee toe looking upstream.

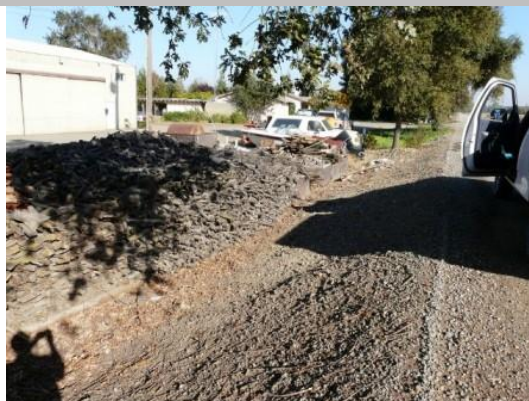
Photo 1 of 1 : SP_2015_NA0017_151_39_20150313_00014.jpg

LM Start	13.52	Rating **	M	Issue No.	39
LM End	13.52	Issue Type +	Ma	Location *	LS
Category	Earthen Levee			GPS Latitude/Longitude	
				Start	End
Item	Encroachments			38.111902 °	38.111902 °
				-121.172685 °	-121.172685 °
DWR ID	DWR_NA0017_07_s_2012_39				
Action/Comments					
Firewood

Move firewood to outside of 10' from landside toe of levee at LM 14.08.

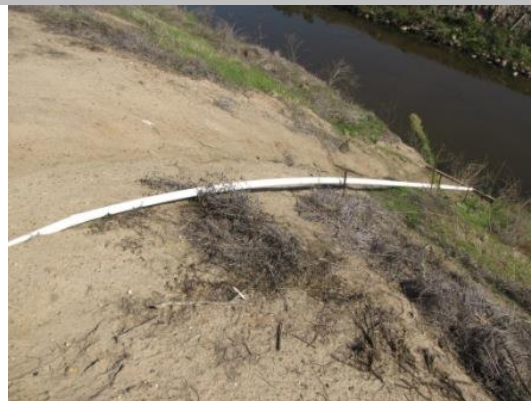
Photo 1 of 1 : SP_2015_NA0017_151_1054_20150313_00062.jpg

LM Start	14.23	Rating **	M	Issue No.	1054
LM End	14.23	Issue Type +	Ma	Location *	WS
Category	Earthen Levee			GPS Latitude/Longitude	
				Start	End
Item	Encroachments			38.121661 °	38.121661 °
				-121.169548 °	-121.169548 °
DWR ID	DWR_NA0017_07_s_2012_1054				
Action/Comments					
Pipe Inspector Comments: Landowner has installed a pipe in the access road to take water from the channel for irrigation. Steps have also been dug into the side of the channel.

View of a pipe a landowner placed in the access road and waterward slope to pump water from the channel to irrigate their garden.

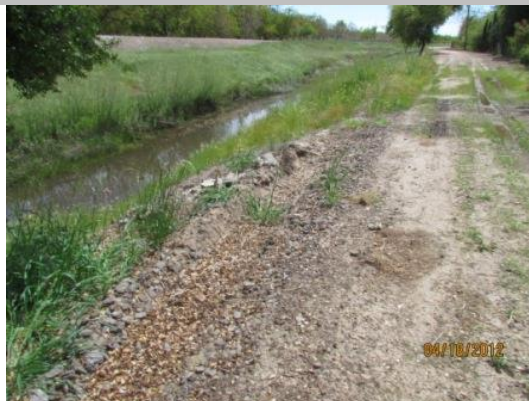
Photo 1 of 1 : SP_2015_NA0017_151_60_20150313_00027.jpg

LM Start	14.35	Rating **	M	Issue No.	60
LM End	14.35	Issue Type +	Ma	Location *	CR
Category	Earthen Levee			GPS Latitude/Longitude	
				Start	End
Item	Crown Surface / Depressions / Rutting			38.123286 °	38.123286 °
				-121.169609 °	-121.169609 °
DWR ID	DWR_NA0017_07_s_2012_60				
Action/Comments					
Repair depressions or ruts in the crown or slope.

Crown depression was found on the waterside shoulder of the levee looking downstream.

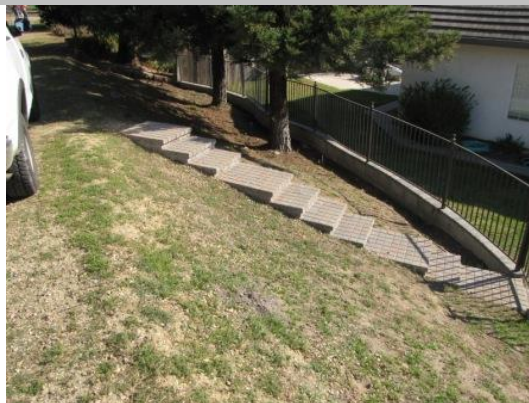
Photo 1 of 1 : SP_2015_NA0017_152_1075_20150313_00087.jpg

LM Start	0.80	Rating **	M	Issue No.	1075
LM End	0.80	Issue Type +	Ma	Location *	LS
Category	Earthen Levee			GPS Latitude/Longitude	
				Start	End
Item	Encroachments			38.053178 °	38.053178 °
				-121.375387 °	-121.375387 °
DWR ID	DWR_NA0017_08_s_2012_1075				
Action/Comments					
Stairway

View of steps on the landward slope looking upstream.

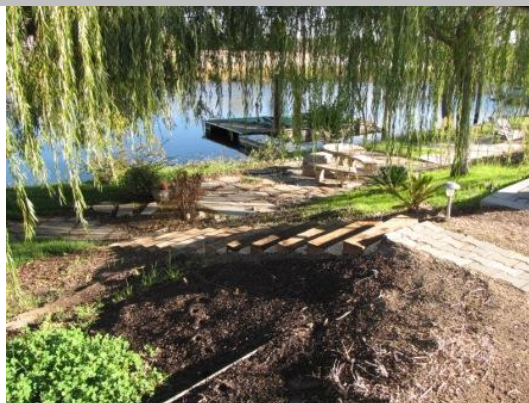
Photo 1 of 1 : SP_2015_NA0017_152_1_20150313_00001.jpg

LM Start	0.92	Rating **	A/W	Issue No.	1
LM End	0.92	Issue Type +	Ma	Location *	LS
Category	Earthen Levee			GPS Latitude/Longitude	
				Start	End
Item	Encroachments			38.043110 °	38.043110 °
				-121.369538 °	-121.369538 °
DWR ID	DWR_NA0017_08_s_2012_1				
Action/Comments					
Stairway Inspector Comments: New stairs on waterward slope.

View of recently modified steps on the waterward slope of the levee looking upstream.

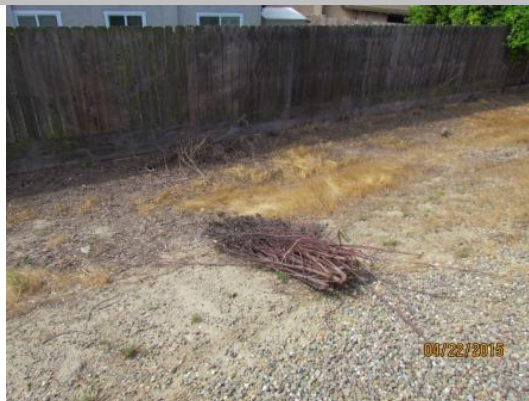
Photo 1 of 1 : SP_2015_NA0017_152_81_20150429_00110.jpg

LM Start	1.66	Rating **	M	Issue No.	81
LM End	1.66	Issue Type +	Ma	Location *	LS
Category	Earthen Levee			GPS Latitude/Longitude	
				Start	End
Item	Encroachments			38.042783 °	38.042783 °
				-121.353818 °	-121.353818 °
DWR ID	DWR_NA0017_08_s_2015_81				
Action/Comments					
Prunings

Prunings were found on the landside slope of the levee looking downstream.

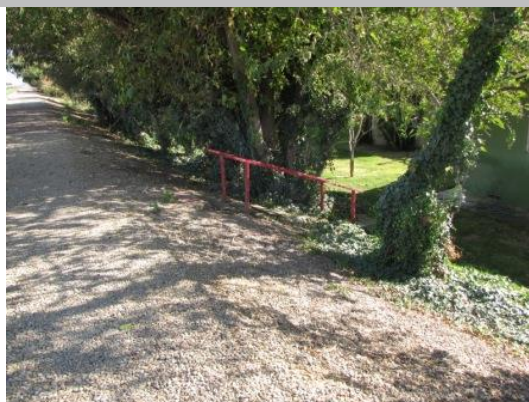
Photo 1 of 1 : SP_2015_NA0017_152_1007_20150313_00057.jpg

LM Start	2.03	Rating **	M	Issue No.	1007
LM End	2.03	Issue Type +	Ma	Location *	LS
Category	Earthen Levee			GPS Latitude/Longitude	
				Start	End
Item	Encroachments			38.042803 °	38.042803 °
				-121.347023 °	-121.347023 °
DWR ID	DWR_NA0017_08_s_2012_1007				
Action/Comments					
Stairway Inspector Comments: Steps were removed but the hand rails still exists at the location.

View of steps dug into the landward slope looking upstream.

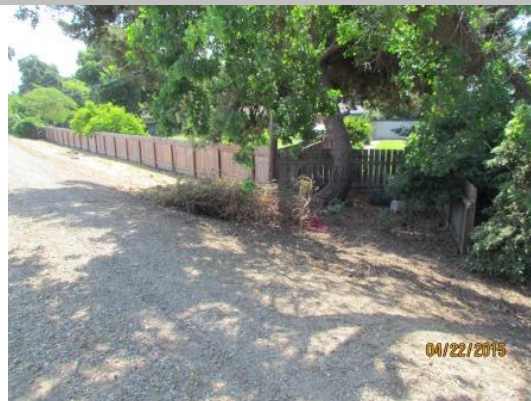
Photo 1 of 1 : SP_2015_NA0017_152_92_20150429_00112.jpg

LM Start	2.04	Rating **	M	Issue No.	92
LM End	2.04	Issue Type +	Ma	Location *	LS
Category	Earthen Levee			GPS Latitude/Longitude	
				Start	End
Item	Encroachments			38.042803 °	38.042803 °
				-121.346755 °	-121.346755 °
DWR ID	DWR_NA0017_08_s_2015_92				
Action/Comments					
Prunings

Prunings were found on the landside of the levee looking upstream.

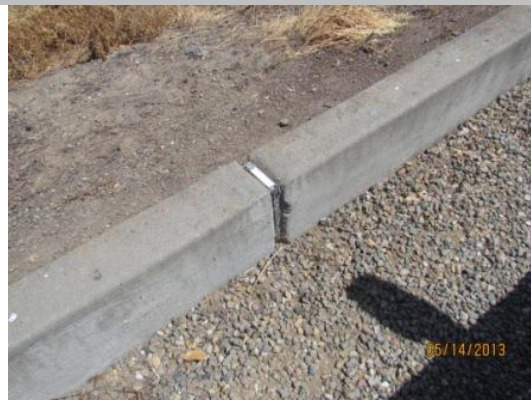
Photo 1 of 1 : SP_2015_NA0017_152_29_20150313_00012.jpg

LM Start	2.24	Rating **	M	Issue No.	29
LM End	2.24	Issue Type +	Ma	Location *	WS
Category	Concrete Floodwalls			GPS Latitude/Longitude	
				Start	End
Item	Monolith Joints			38.042777 °	38.042777 °
				-121.343150 °	-121.343150 °
DWR ID	DWR_NA0017_08_s_2013_29				
Action/Comments

The monolith joint material is deteriorating at this location of the flood wall. The picture was taken from the crown looking upstream.

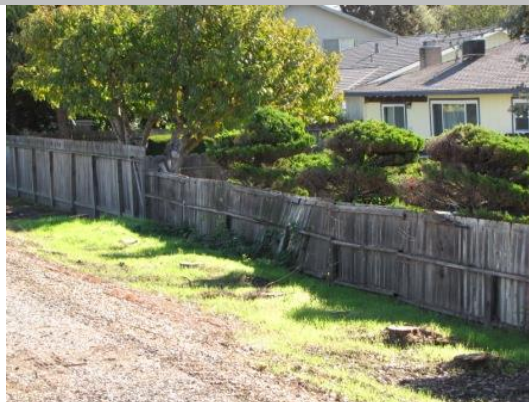
Photo 1 of 1 : SP_2015_NA0017_152_12_20150313_00003.jpg

LM Start	2.50	Rating **	N	Issue No.	12
LM End	2.50	Issue Type +	Ma	Location *	LS
Category	Earthen Levee			GPS Latitude/Longitude	
				Start	End
Item	Trim / Thin Trees			38.042749 °	38.042749 °
				-121.338402 °	-121.338402 °
DWR ID	DWR_NA0017_08_s_2012_12				
Action/Comments					
Tree stumps.

View of stumps along the landward toe looking upstream.

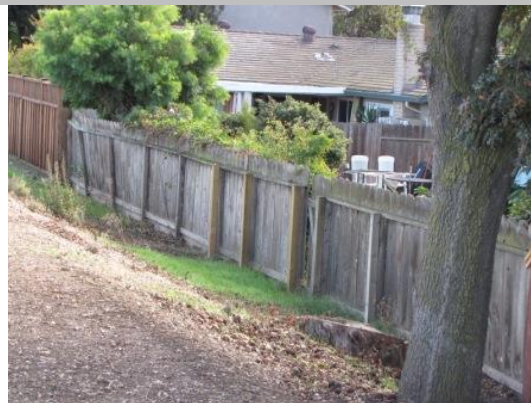
Photo 1 of 1 : SP_2015_NA0017_152_13_20150313_00004.jpg

LM Start	3.19	Rating **	N	Issue No.	13
LM End	3.19	Issue Type +	Ma	Location *	LS
Category	Earthen Levee			GPS Latitude/Longitude	
				Start	End
Item	Trim / Thin Trees			38.042676 °	38.042676 °
				-121.325694 °	-121.325694 °
DWR ID	DWR_NA0017_08_s_2012_13				
Action/Comments					
Tree stumps.

View of a stump on the landward slope looking upstream.

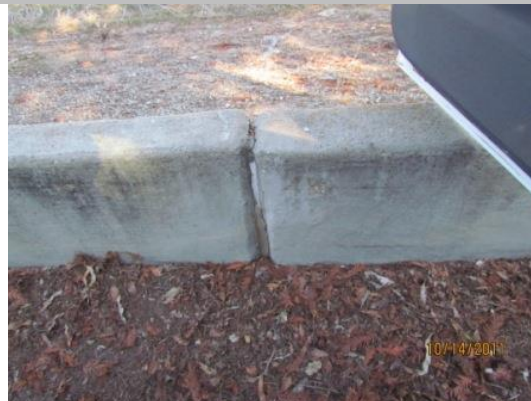
Photo 1 of 1 : SP_2015_NA0017_152_940_20150313_00053.jpg

LM Start	3.31	Rating **	M	Issue No.	940
LM End	3.31	Issue Type +	Ma	Location *	LS
Category	Concrete Floodwalls			GPS Latitude/Longitude	
				Start	End
Item	Monolith Joints			38.042654 °	38.042654 °
				-121.325611 °	-121.325611 °
DWR ID	DWR_NA0017_08_s_2012_940				
Action/Comments

Monolith joint material is deteriorating at the joint of the flood wall. The picture was taken from the crown looking upstream.

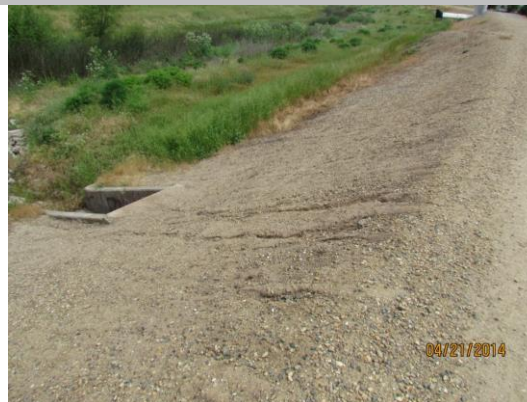
Photo 1 of 1 : SP_2015_NA0017_152_27_20150313_00010.jpg

LM Start	4.56	Rating **	M	Issue No.	27
LM End	4.56	Issue Type +	Ma	Location *	WS
Category	Earthen Levee			GPS Latitude/Longitude	
				Start	End
Item	Erosion / Bank Caving			38.042797 °	38.042797 °
				-121.300782 °	-121.300782 °
DWR ID	DWR_NA0017_08_s_2014_27				
Action/Comments					
Schedule repair of erosion site prior to the next inspection.					
Inspector Comments: Ruts on the waterside slope of the levee.

Erosion caused by runoffs on the waterside slope of the levee looking upstream.

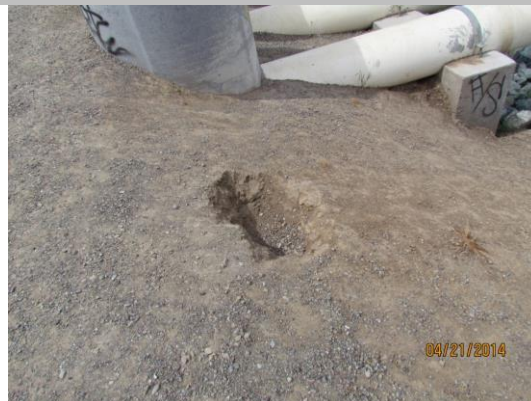
Photo 1 of 1 : SP_2015_NA0017_152_46_20150313_00020.jpg

LM Start	4.60	Rating **	M	Issue No.	46
LM End	4.60	Issue Type +	Ma	Location *	WS
Category	Earthen Levee			GPS Latitude/Longitude	
				Start	End
Item	Slope Stability			38.043093 °	38.043093 °
				-121.300166 °	-121.300166 °
DWR ID	DWR_NA0017_08_s_2014_46				
Action/Comments					
Repair slope instability.

A slope instability was found on the waterside of the levee looking downstream.

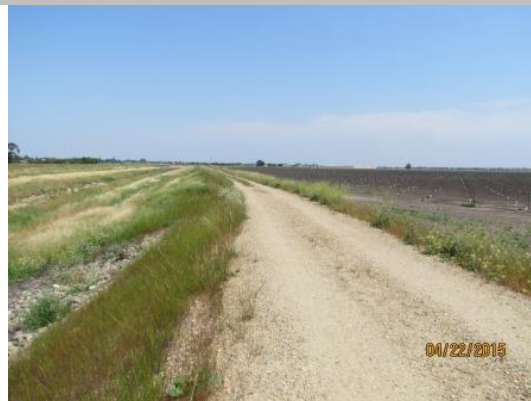
Photo 1 of 1 : SP_2015_NA0017_152_23_20150429_00114.jpg

LM Start	4.91	Rating **	M	Issue No.	23
LM End	6.06	Issue Type +	Ma	Location *	WS
Category	Earthen Levee			GPS Latitude/Longitude	
				Start	End
Item	Vegetation			38.044287 °	38.052272 °
				-121.294864 °	-121.277921 °
DWR ID	DWR_NA0017_08_s_2015_23				
Action/Comments					
Control annual grass and weeds on the levee slopes and easements.

View of vegetation along the waterside of the levee looking upstream.

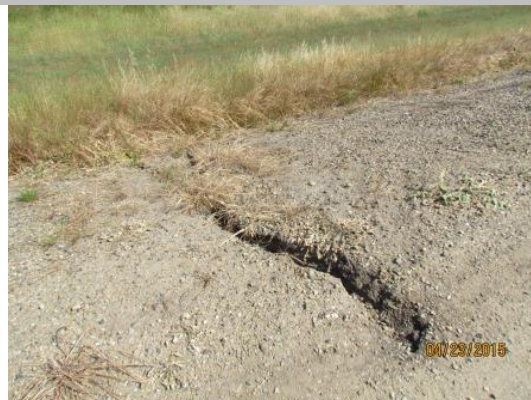
Photo 1 of 1 : SP_2015_NA0017_152_120_20150429_00116.jpg

LM Start	6.53	Rating **	M	Issue No.	120
LM End	6.53	Issue Type +	Ma	Location *	WS
Category	Earthen Levee			GPS Latitude/Longitude	
				Start	End
Item	Erosion / Bank Caving			38.052994 °	38.052994 °
				-121.271526 °	-121.271526 °
DWR ID	DWR_NA0017_08_f_2014_120				
Action/Comments					
Schedule repair of erosion site prior to the next inspection. Inspector Comments: Surface runoff.

View of the slope instability due to runoff on the waterside of the levee looking upstream.

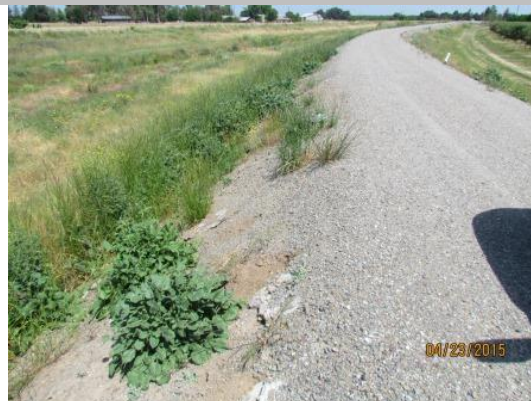
Photo 1 of 1 : SP_2015_NA0017_152_94_20150429_00118.jpg

LM Start	10.52	Rating **	M	Issue No.	94
LM End	10.52	Issue Type +	Ma	Location *	WS
Category	Earthen Levee			GPS Latitude/Longitude	
				Start	End
Item	Animal Control			38.076880 °	38.076880 °
				-121.207703 °	-121.207703 °
DWR ID	DWR_NA0017_08_s_2015_94				
Action/Comments					
No rodents visible, but rodent burrows visible; need to backfill and compact or grout burrows.

Rodent holes were found on the waterside of the levee looking upstream.

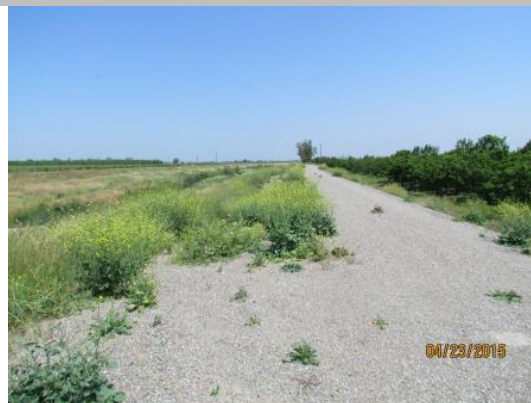
Photo 1 of 1 : SP_2015_NA0017_152_97_20150429_00119.jpg

LM Start	10.99	Rating **	M	Issue No.	97
LM End	12.37	Issue Type +	Ma	Location *	WS
Category	Earthen Levee			GPS Latitude/Longitude	
				Start	End
Item	Vegetation			38.080015 °	38.091745 °
				-121.200352 °	-121.181633 °
DWR ID	DWR_NA0017_08_s_2015_97				
Action/Comments					
Control annual grass and weeds on the levee slopes and easements.

View of vegetation along the waterside of the levee looking upstream.

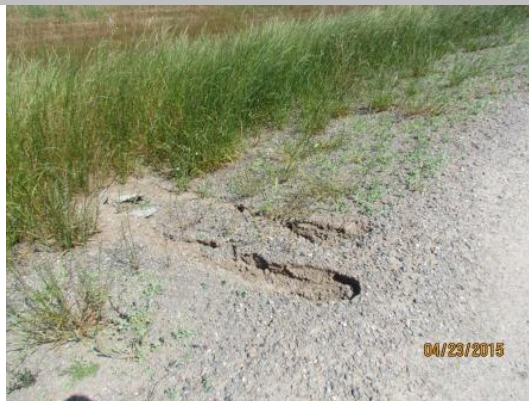
Photo 1 of 1 : SP_2015_NA0017_152_109_20150429_00120.jpg

LM Start	11.66	Rating **	M	Issue No.	109
LM End	11.66	Issue Type +	Ma	Location *	WS
Category	Earthen Levee			GPS Latitude/Longitude	
				Start	End
Item	Slope Stability			38.086023 °	38.086023 °
				-121.191252 °	-121.191252 °
DWR ID	DWR_NA0017_08_s_2015_109				
Action/Comments					
Repair slope instability.

View of slope instability on the waterside of the levee looking upstream.

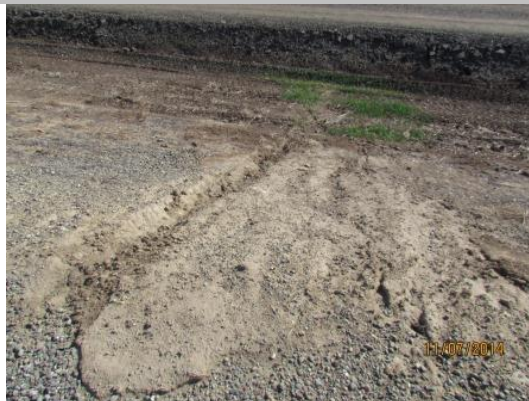
Photo 1 of 1 : SP_2015_NA0017_152_128_20150313_00047.jpg

LM Start	11.81	Rating **	M	Issue No.	128
LM End	11.81	Issue Type +	Ma	Location *	LS
Category	Earthen Levee			GPS Latitude/Longitude	
				Start	End
Item	Erosion / Bank Caving			38.086116 °	38.086116 °
				-121.190630 °	-121.190630 °
DWR ID	DWR_NA0017_08_f_2014_128				
Action/Comments					
Schedule repair of erosion site prior to the next inspection.

Erosion was found on the landside of the levee looking upstream.

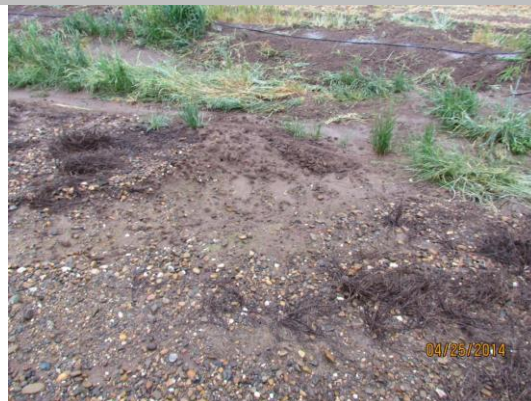
Photo 1 of 1 : SP_2015_NA0017_152_83_20150313_00030.jpg

LM Start	13.35	Rating **	M	Issue No.	83
LM End	13.35	Issue Type +	Ma	Location *	LS
Category	Earthen Levee			GPS Latitude/Longitude	
				Start	End
Item	Slope Stability			38.101934 °	38.101934 °
				-121.177144 °	-121.177144 °
DWR ID	DWR_NA0017_08_s_2014_83				
Action/Comments					
Repair the levee slope damaged by vehicle traffic and prevent access where possible.

A slope instability was found on the landside of the levee looking upstream.

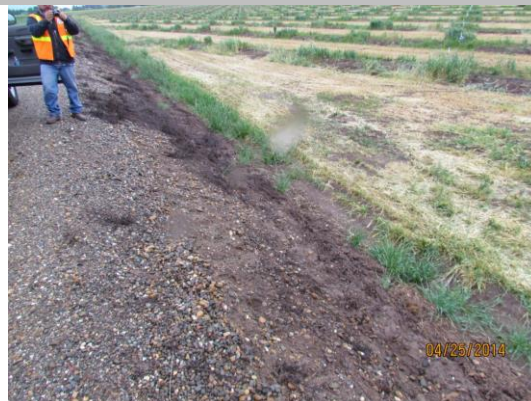
Photo 1 of 1 : SP_2015_NA0017_152_84_20150313_00031.jpg

LM Start	13.42	Rating **	M	Issue No.	84
LM End	13.42	Issue Type +	Ma	Location *	LS
Category	Earthen Levee			GPS Latitude/Longitude	
				Start	End
Item	Encroachments			38.102876 °	38.102876 °
				-121.177057 °	-121.177057 °
DWR ID	DWR_NA0017_08_s_2014_84				
Action/Comments					
Agricultural tilling

Tilling along the landside toe was found at this location. The picture was taken from the crown looking upstream.

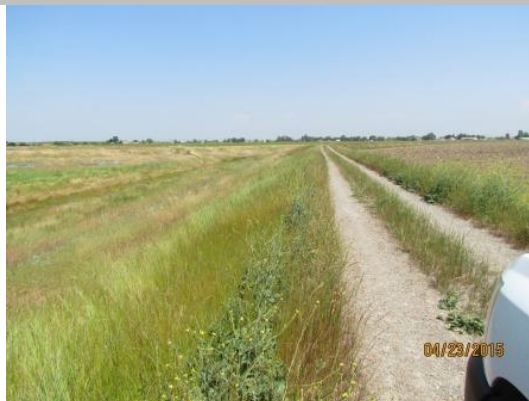
Photo 1 of 1 : SP_2015_NA0017_153_4_20150429_00003.jpg

LM Start	0.02	Rating **	M	Issue No.	4
LM End	1.43	Issue Type +	Ma	Location *	WS
Category	Earthen Levee			GPS Latitude/Longitude	
				Start	End
Item	Vegetation			38.093280 °	38.094090 °
				-121.176182 °	-121.151072 °
DWR ID	DWR_NA0017_09_s_2015_4				
Action/Comments					
Control annual grass and weeds on the levee slopes and easements.

View of vegetation along the waterside of the levee looking upstream.

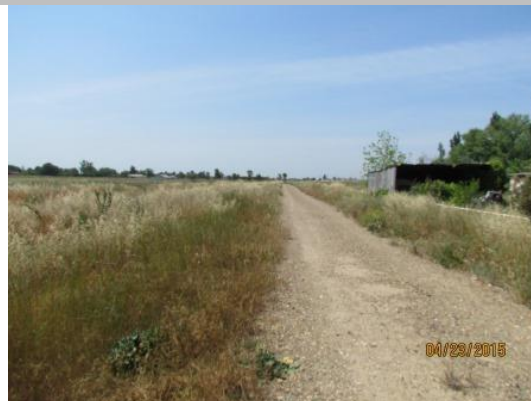
Photo 1 of 1 : SP_2015_NA0017_154_4_20150429_00006.jpg

LM Start	0.36	Rating **	M	Issue No.	4
LM End	1.32	Issue Type +	Ma	Location *	WS
Category	Earthen Levee			GPS Latitude/Longitude	
				Start	End
Item	Vegetation			38.095043 °	38.094357 °
				-121.168347 °	-121.150953 °
DWR ID	DWR_NA0017_10_s_2015_4				
Action/Comments					
Control annual grass and weeds on the levee slopes and easements.

View of vegetation along the waterside of the levee looking downstream.

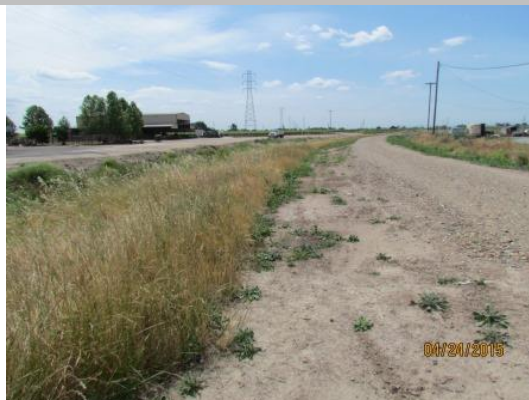
Photo 1 of 1 : SP_2015_NA0017_155_22_20150429_00016.jpg

LM Start	0.05	Rating **	M	Issue No.	22
LM End	3.52	Issue Type +	Ma	Location *	WS
Category	Earthen Levee			GPS Latitude/Longitude	
				Start	End
Item	Vegetation			38.095561 °	38.131635 °
				-121.169359 °	-121.138829 °
DWR ID	DWR_NA0017_11_s_2015_22				
Action/Comments					
Control annual grass and weeds on the levee slopes and easements.

View of vegetation along the waterside of the levee looking downstream.

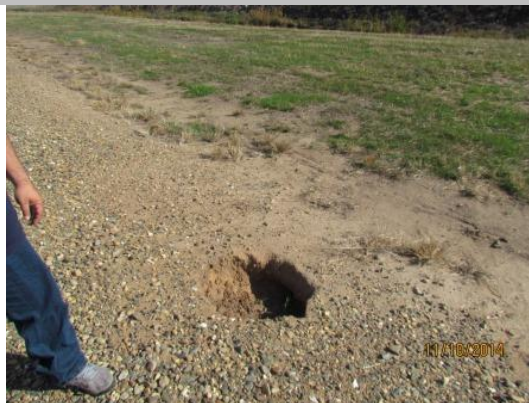
Photo 1 of 1 : SP_2015_NA0017_155_23_20150313_00009.jpg

LM Start	2.07	Rating **	M	Issue No.	23
LM End	2.07	Issue Type +	Ma	Location *	WS
Category	Earthen Levee			GPS Latitude/Longitude	
				Start	End
Item	Slope Stability			38.117370 °	38.117370 °
				-121.153446 °	-121.153446 °
DWR ID	DWR_NA0017_11_f_2014_23				
Action/Comments					
Repair slope instability.

A slope instability was found on the waterside shoulder of the levee looking upstream.

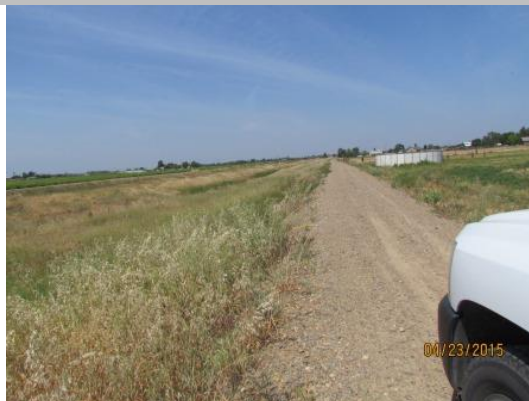
Photo 1 of 1 : SP_2015_NA0017_156_15_20150429_00025.jpg

LM Start	0.02	Rating **	M	Issue No.	15
LM End	0.46	Issue Type +	Ma	Location *	WS
Category	Earthen Levee			GPS Latitude/Longitude	
				Start	End
Item	Vegetation			38.095312 °	38.101627 °
				-121.168770 °	-121.168005 °
DWR ID	DWR_NA0017_12_s_2015_15				
Action/Comments					
Control annual grass and weeds on the levee slopes and easements.

View of vegetation along the waterside of the levee looking upstream.

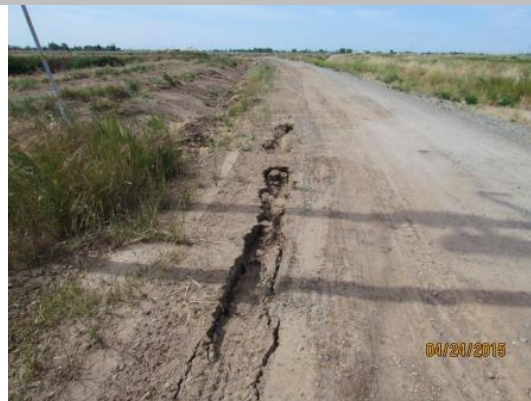
Photo 1 of 1 : SP_2015_NA0017_156_34_20150429_00026.jpg

LM Start	1.95	Rating **	M	Issue No.	34
LM End	1.95	Issue Type +	Ma	Location *	CR
Category	Earthen Levee			GPS Latitude/Longitude	
				Start	End
Item	Crown Surface / Depressions / Rutting			38.116508 °	38.116508 °
				-121.154252 °	-121.154252 °
DWR ID	DWR_NA0017_12_s_2015_34				
Action/Comments					
Repair depressions or ruts in the crown or slope.

View of crown depression caused by vehicle looking downstream.

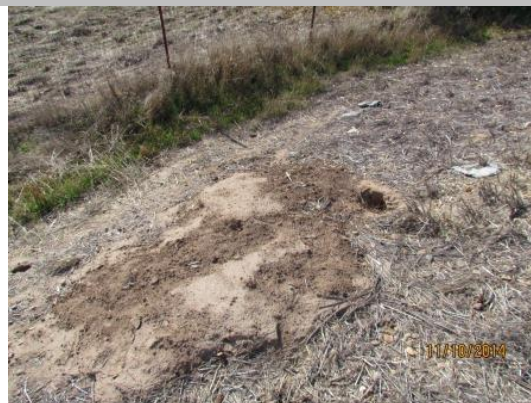
Photo 1 of 2 : SP_2015_NA0017_156_9_20150313_00007.jpg

LM Start	2.22	Rating **	M	Issue No.	9
LM End	2.22	Issue Type +	Ma	Location *	LS
Category	Earthen Levee			GPS Latitude/Longitude	
				Start	End
Item	Animal Control			38.117784 °	38.117784 °
				-121.149763 °	-121.149763 °
DWR ID	DWR_NA0017_12_s_2014_9				
Action/Comments					
No rodents visible, but rodent burrows visible; need to backfill and compact or grout burrows.

Updated picture of the rodent holes on the landside of the levee looking downstream.

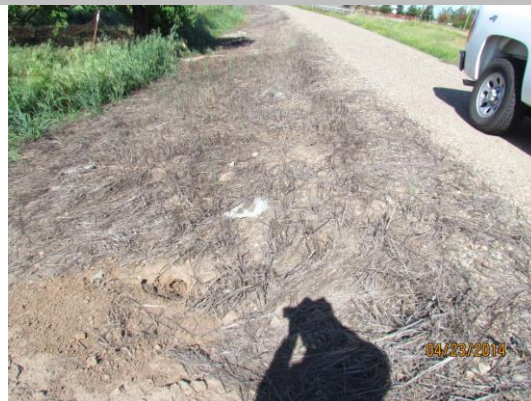
Photo 2 of 2 : SP_2015_NA0017_156_9_20150313_00008.jpg

LM Start	2.22	Rating **	M	Issue No.	9 (cont)
LM End	2.22	Issue Type +	Ma	Location *	LS

View of a rodent hole that was found on the landside of the levee looking downstream.

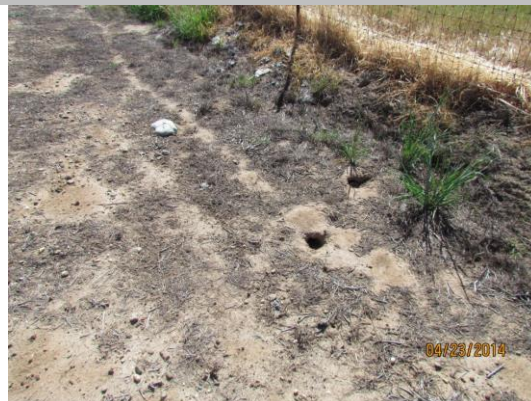
Photo 1 of 1 : SP_2015_NA0017_156_11_20150313_00010.jpg

LM Start	2.25	Rating **	M	Issue No.	11
LM End	2.25	Issue Type +	Ma	Location *	LS
Category	Earthen Levee			GPS Latitude/Longitude	
				Start	End
Item	Animal Control			38.117807 °	38.117807 °
				-121.149233 °	-121.149233 °
DWR ID	DWR_NA0017_12_s_2014_11				
Action/Comments					
No rodents visible, but rodent burrows visible; need to backfill and compact or grout burrows.

View of rodent holes that were found on the landside toe of the levee upstream.

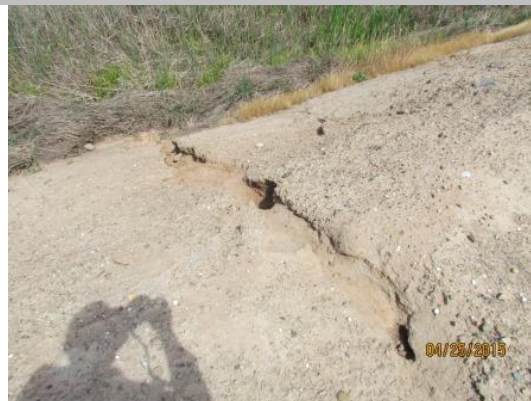
Photo 1 of 1 : SP_2015_NA0017_156_21_20150429_00028.jpg

LM Start	2.64	Rating **	M	Issue No.	21
LM End	2.64	Issue Type +	Ma	Location *	WS
Category	Earthen Levee			GPS Latitude/Longitude	
				Start	End
Item	Slope Stability			38.121790 °	38.121790 °
				-121.145020 °	-121.145020 °
DWR ID	DWR_NA0017_12_s_2015_21				
Action/Comments					
Repair slope instability. Inspector Comments: Runoff

View of slope instability due to runoff on the waterside of the levee looking upstream.

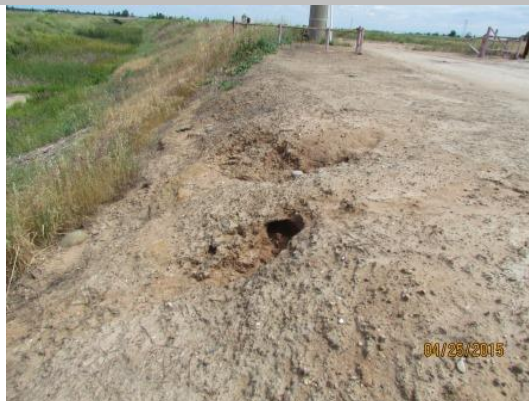
Photo 1 of 1 : SP_2015_NA0017_156_36_20150429_00029.jpg

LM Start	2.67	Rating **	M	Issue No.	36
LM End	2.67	Issue Type +	Ma	Location *	WS
Category	Earthen Levee			GPS Latitude/Longitude	
				Start	End
Item	Animal Control			38.122209 °	38.122209 °
				-121.144633 °	-121.144633 °
DWR ID	DWR_NA0017_12_s_2015_36				
Action/Comments					
No rodents visible, but rodent burrows visible; need to backfill and compact or grout burrows.

Rodent holes were found on the waterside of the levee looking upstream.

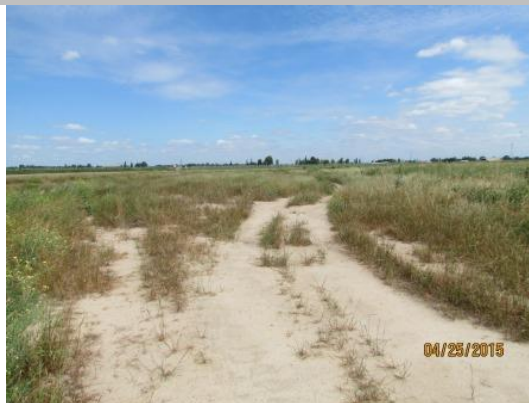
Photo 1 of 1 : SP_2015_NA0017_156_37_20150429_00030.jpg

LM Start	2.70	Rating **	M	Issue No.	37
LM End	3.26	Issue Type +	Ma	Location *	CR
Category	Earthen Levee			GPS Latitude/Longitude	
				Start	End
Item	Vegetation			38.122479 °	38.128432 °
				-121.144428 °	-121.139606 °
DWR ID	DWR_NA0017_12_s_2015_37				
Action/Comments					
Control annual grass and weeds on the levee slopes and easements.

View of vegetation along the crown of the levee looking upstream.

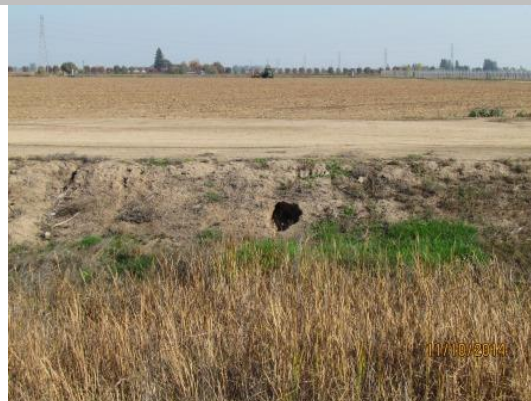
Photo 1 of 2 : SP_2015_NA0017_156_16_20150313_00012.jpg

LM Start	2.74	Rating **	U	Issue No.	16
LM End	2.74	Issue Type +	Ma	Location *	WS
Category	Earthen Levee			GPS Latitude/Longitude	
				Start	End
Item	Animal Control			38.123222 °	38.123222 °
				-121.144640 °	-121.144640 °
DWR ID	DWR_NA0017_12_s_2014_16				
Action/Comments					
No rodents visible, but rodent burrows visible; need to backfill and compact or grout burrows. Inspector Comments: Animal hole got bigger caused by erosion.

Updated picture of a rodent hole on the waterside of the levee. The picture was taken from the opposite side of the levee during fall 2014 inspection.

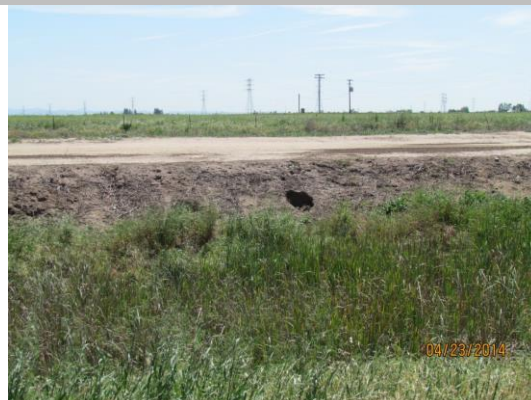
Photo 2 of 2 : SP_2015_NA0017_156_16_20150313_00013.jpg

View of a rodent hole on the waterside slope of the levee. The picture was taken from the opposite side of the levee.

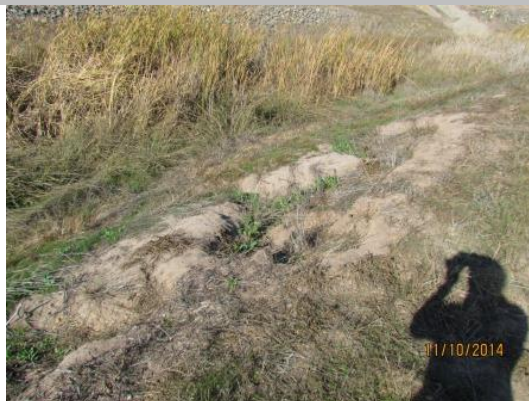
Photo 1 of 1 : SP_2015_NA0017_156_32_20150313_00022.jpg

LM Start	2.97	Rating **	M	Issue No.	32
LM End	2.97	Issue Type +	Ma	Location *	WS
Category	Earthen Levee			GPS Latitude/Longitude	
				Start	End
Item	Slope Stability			38.126304 °	38.126304 °
				-121.143996 °	-121.143996 °
DWR ID	DWR_NA0017_12_f_2014_32				
Action/Comments					
Repair slope instability.

View of a slope instability that was found on the waterside of the levee looking upstream.

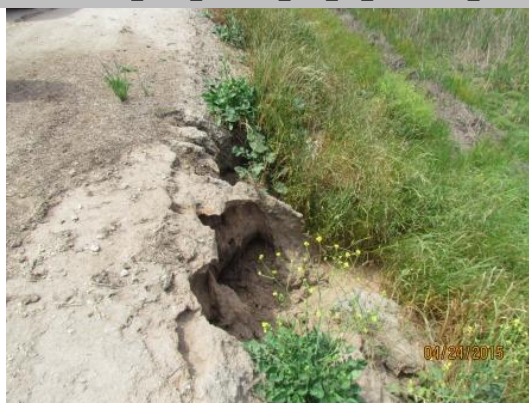
Photo 1 of 2 : SP_2015_NA0017_156_12_20150429_00031.jpg

LM Start	3.14	Rating **	M	Issue No.	12
LM End	3.14	Issue Type +	Ma	Location *	WS
Category	Earthen Levee			GPS Latitude/Longitude	
				Start	End
Item	Erosion / Bank Caving			38.127388 °	38.127388 °
				-121.141197 °	-121.141197 °
DWR ID	DWR_NA0017_12_s_2012_12				
Action/Comments					
Schedule repair of erosion site prior to the next inspection.

Updated picture of the erosion on the waterside of the levee looking downstream during spring 2015 inspection.

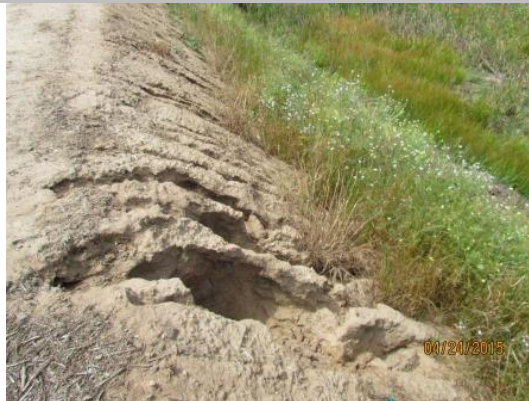
Photo 1 of 3 : SP_2015_NA0017_156_23_20150429_00032.jpg

LM Start	3.26	Rating **	M	Issue No.	23
LM End	3.26	Issue Type +	Ma	Location *	WS
Category	Earthen Levee			GPS Latitude/Longitude	
				Start	End
Item	Erosion / Bank Caving			38.128445 °	38.128445 °
				-121.139594 °	-121.139594 °
DWR ID	DWR_NA0017_12_f_2012_23				
Action/Comments					
Schedule repair of erosion site prior to the next inspection.

Updated picture of the erosion on the waterside of the levee during spring 2015 inspection.

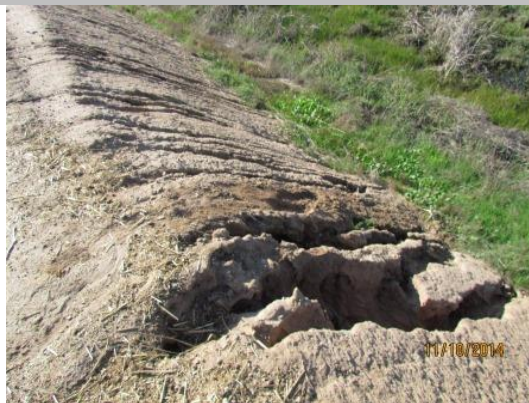
Photo 2 of 3 : SP_2015_NA0017_156_23_20150313_00015.jpg

Updated picture of the erosion on the waterside of the levee. The picture was taken during the fall 2014 inspection looking upstream.
